**SHEPHERD**  
**HOME REPORT**

FLAT 4  
16 ASHLEY PLACE  
EDINBURGH  
EH6 5FH

# Energy Performance Certificate (EPC)

# Scottish Single Survey

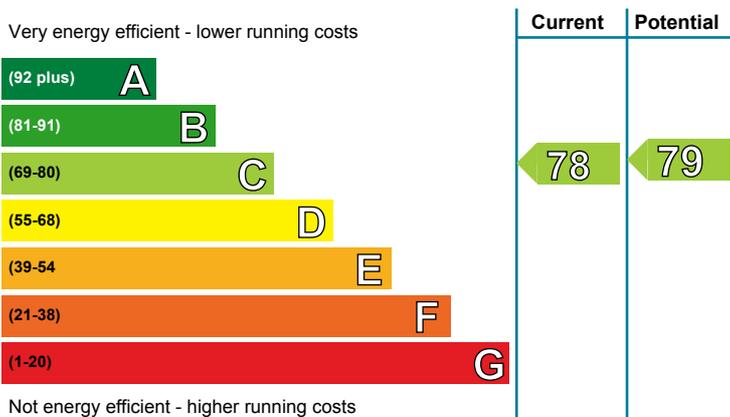
## Energy Efficiency Rating

This graph shows the current efficiency of your home, taking into account both energy efficiency and fuel costs. The higher this rating, the lower your fuel bills are likely to be.

Your current rating is **band C (78)**. The average rating for EPCs in Scotland is **band D (61)**.

The potential rating shows the effect of undertaking all of the improvement measures listed within your recommendations report.

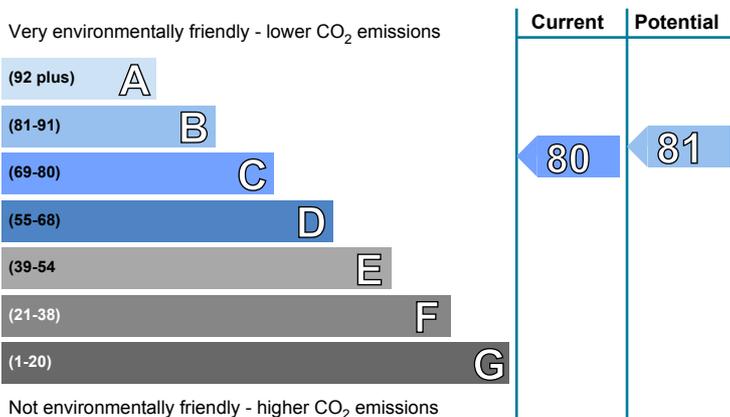
## Environmental Impact (CO<sub>2</sub>) Rating

This graph shows the effect of your home on the environment in terms of carbon dioxide (CO<sub>2</sub>) emissions. The higher the rating, the less impact it has on the environment.

Your current rating is **band C (80)**. The average rating for EPCs in Scotland is **band D (59)**.

The potential rating shows the effect of undertaking all of the improvement measures listed within your recommendations report.
